MERCEDES 722.3-722.4 SLIPPING AND/OR NO REVERSE

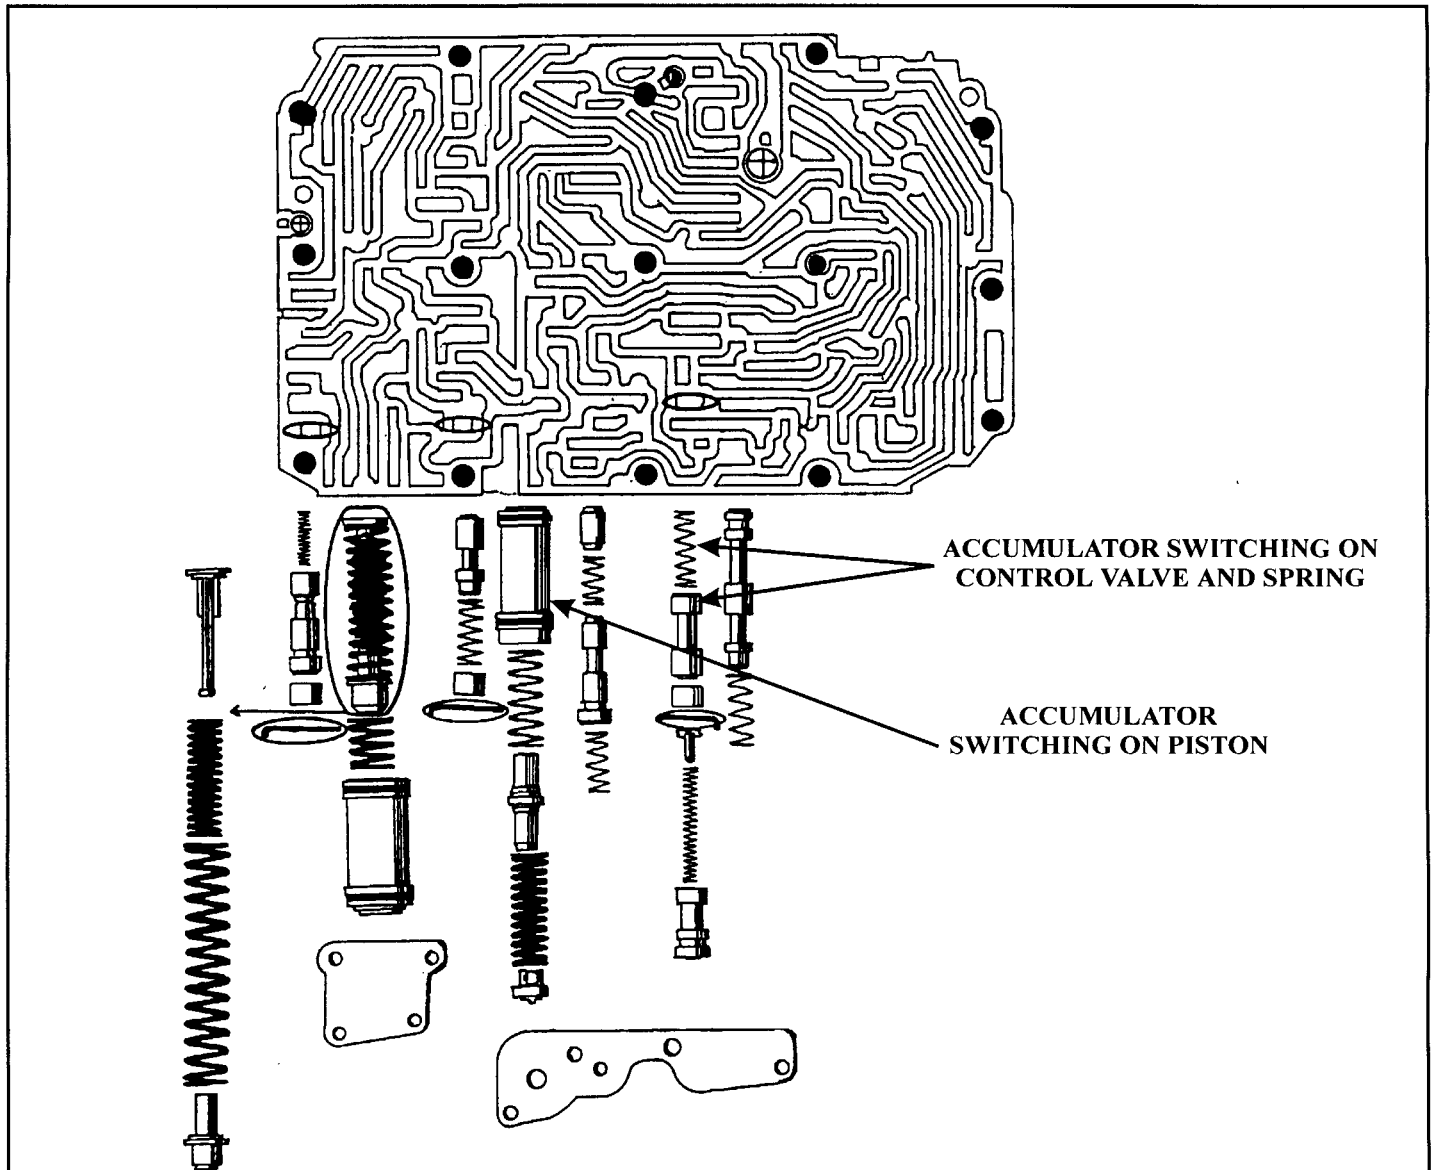
Figure 1

COMPLAINT: Before and/or after rebuild, any Mercedes equipped with the 722.3 - 722.4 transmission may exhibit a chattering in reverse, slipping in reverse, or no reverse.

CAUSE: The cause may be, a stuck or sticking *Accumulator Switching On Control Valve*, a collapsed or broken *Accumulator Switching On Control Valve Spring*, a missing, cut, or leaking seal ring on the accumulator piston, or a cracked *Accumulator Switching On Piston* (See Figure 1).

CORRECTION: Remove and disassemble the valve body. Inspect and replace as necessary, the parts and concerns listed above, as shown in Figure 1.
